NATIONAL BUREAU OF STANDARDS REPORT

9947

FAILED MCCAULEY PROPELLER HUB

T. R. Shives
Engineering Metallurgy Section
Metallurgy Division

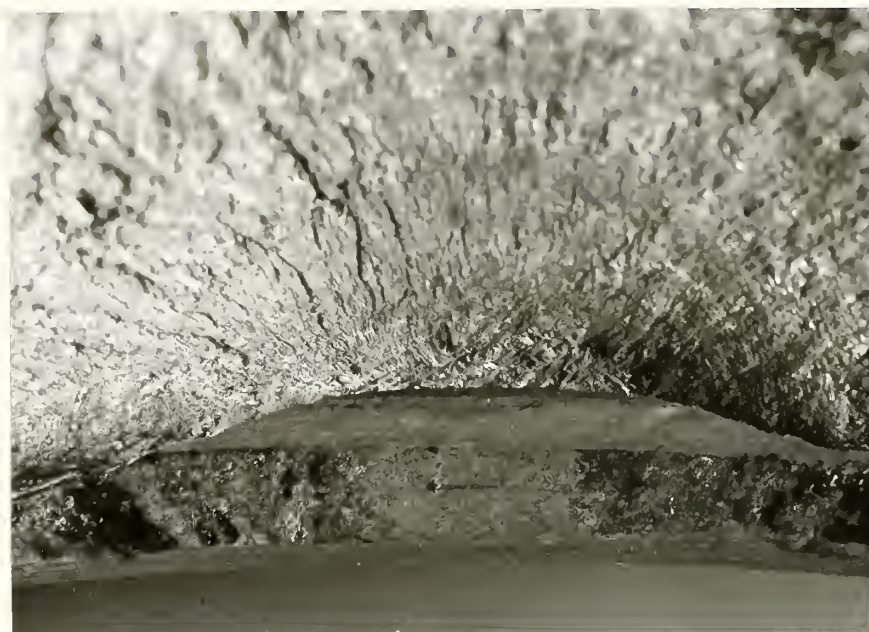
Metallographic Examination: The fracture originated at a fatigue crack near the root of the innermost thread in blade socket No. 2 and extended across the socket (fig. 1). The fracture surface is shown in figures 3 and 4. The fracture was sectioned adjacent to the fatigue crack origin and examined metallographically. Figure 5 shows a representative area of the material in the unetched condition near the crack origin. The material is clean and shows little or no porosity. Figures 6 and 7 show

Figure 4. Origin of fatigue crack in failed hub socket, No. 2. X 10

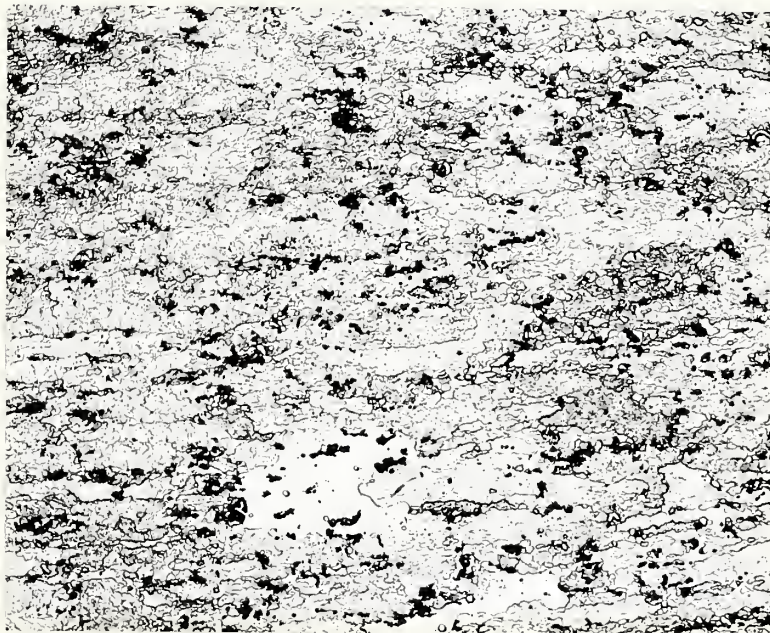
the microstructure of the hub socket adjacent to the crack origin and away from the origin, respectively. There appears to be nothing abnormal or detrimental in the 2014-T6 heat treated structure shown. The smaller grain size observed immediately adjacent to the fracture origin may have resulted from relatively faster cooling after forging in this area. No unusual material condition that may have contributed to crack initiation was found at the origin.

Figure 6. Longitudinal microstructure immediately adjacent to origin of fracture. Keller's etch. X 100

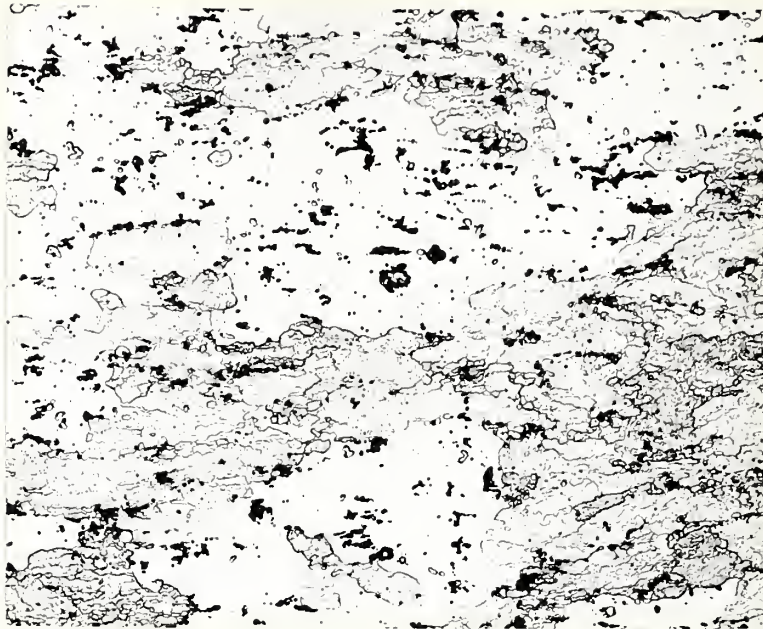
Figure 7. Microstructure of longitudinal section away from fracture. Keller's etch. X 100

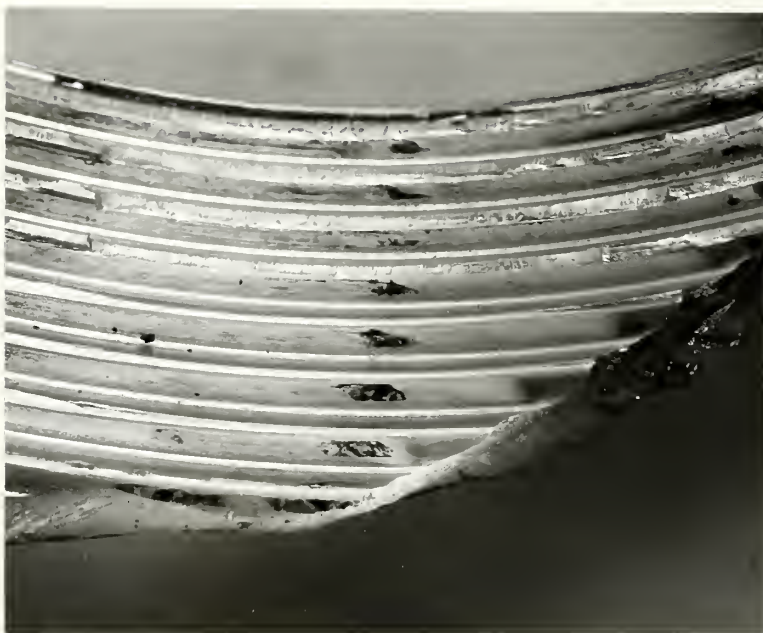
Thread Examination: There was a good deal of fretting in the threads of all three blade sockets as well as in the threads of the retention nut from socket No. 2 (figs. 8 and 9). (The other two retention nuts were not available for examination.) Fretting occurred adjacent to, but not directly at the fatigue crack origin.

The oversize minor diameter found in measuring socket No. 3 indicates a possible mismatch between this socket and its related retention nut. It is conceivable that the mismatch is responsible for the fretting observed in the threads of socket No. 3. Inasmuch as fretting was also observed in the threads of sockets No. 1 and No. 2, it would seem that a mismatch condition was also present in these sockets.

Fretting is indicative of cyclic stressing and it is possible that this stressing could have initiated the fatigue crack that propagated to cause the failure of the hub in socket No. 2. Fatigue cracks may be associated with fretting, and their origins, as in this case, are sometimes found not directly in a fretted area, but adjacent to it.

Figure 8. Threads of failed hub socket showing fretting. X 2

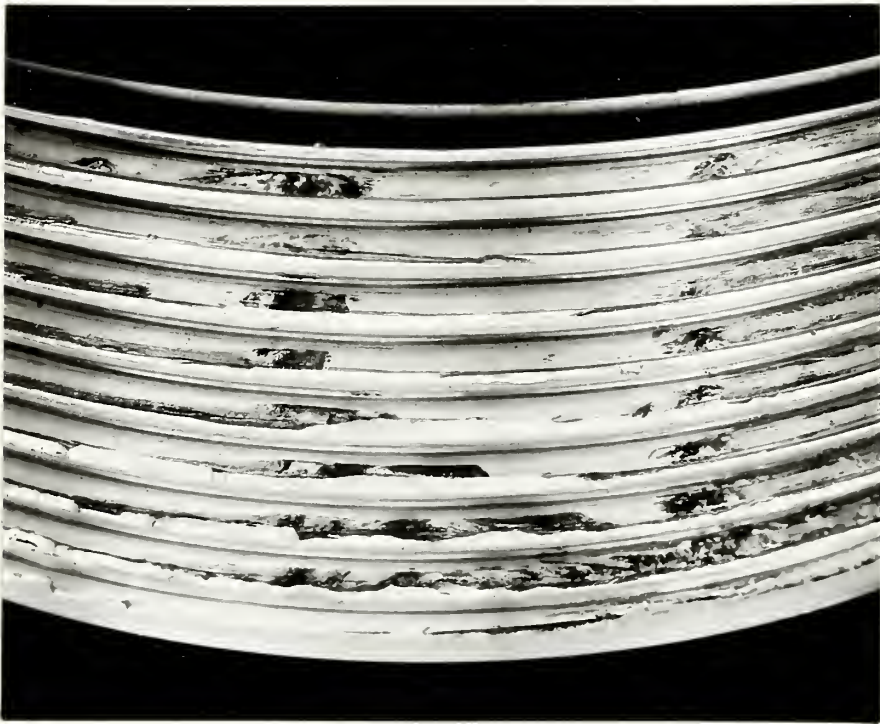
Figure 9. Threads of blade retention nut showing fretting. X 2

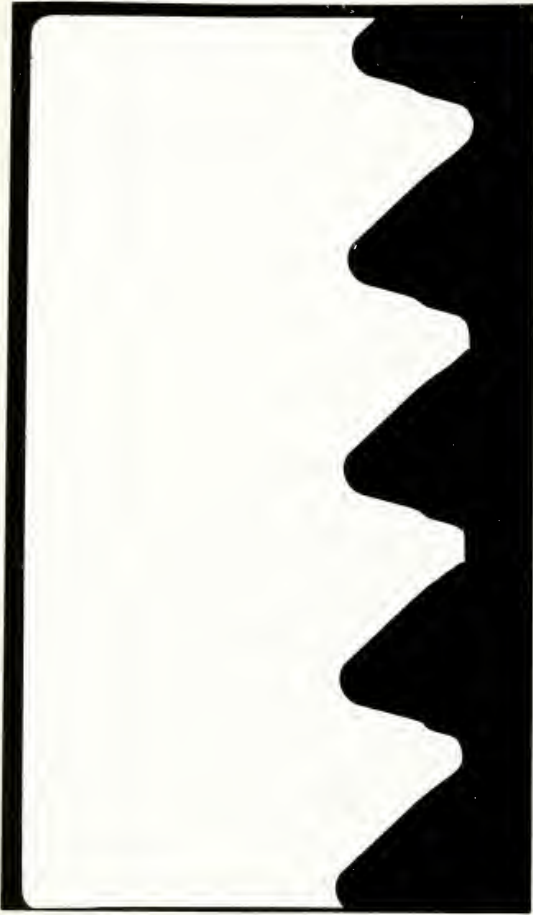
The threads over a large portion of the blade retention nut were rather badly damaged. Figure 10 shows the thread profile in a damaged area as well as in an area where the threads are intact. The thread profile appears satisfactory in the undamaged area.

Figure 10a. Thread profile of
damaged threads of
blade retention nut.
X 7

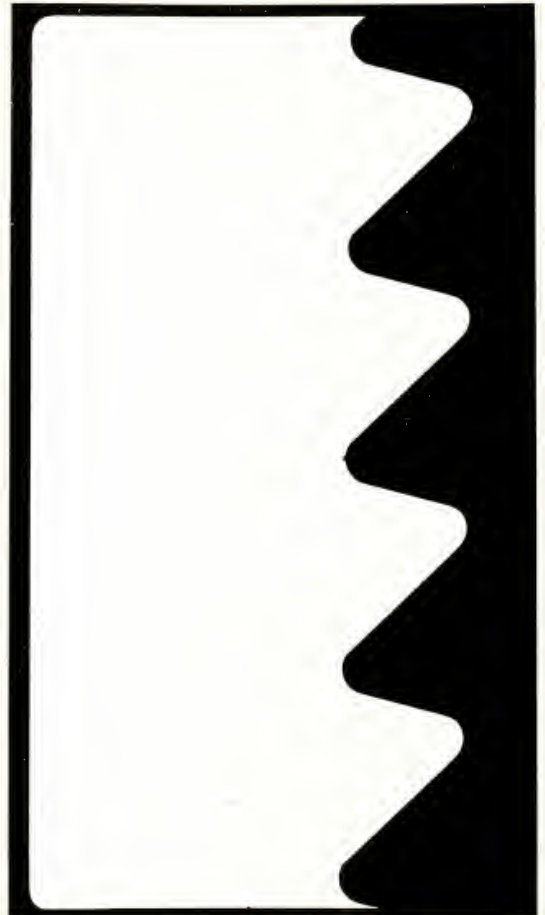
Figure 10b. Thread profile of
undamaged threads of
blade retention nut.
X 7

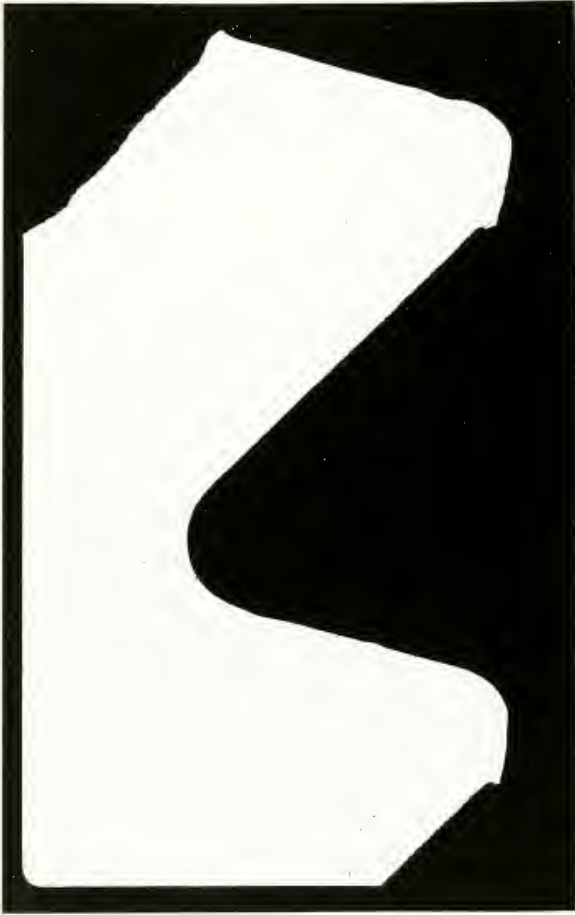
The threads of the failed hub socket were also damaged badly as is shown by the profile of two threads adjacent to the fracture (fig. 11a). Figure 11b shows the thread profile of socket No. 1 which was not damaged and the threads appear to be satisfactory. In figure 12, the thread nearest to the fracture is shown at a higher magnification. The material has been deeply etched to show flow. The top of the thread has been severely deformed. Other damaged threads exhibited deformation of this nature.

Figure 11a. Thread profile of hub socket No. 2 showing two damaged threads adjacent to fracture. X 18

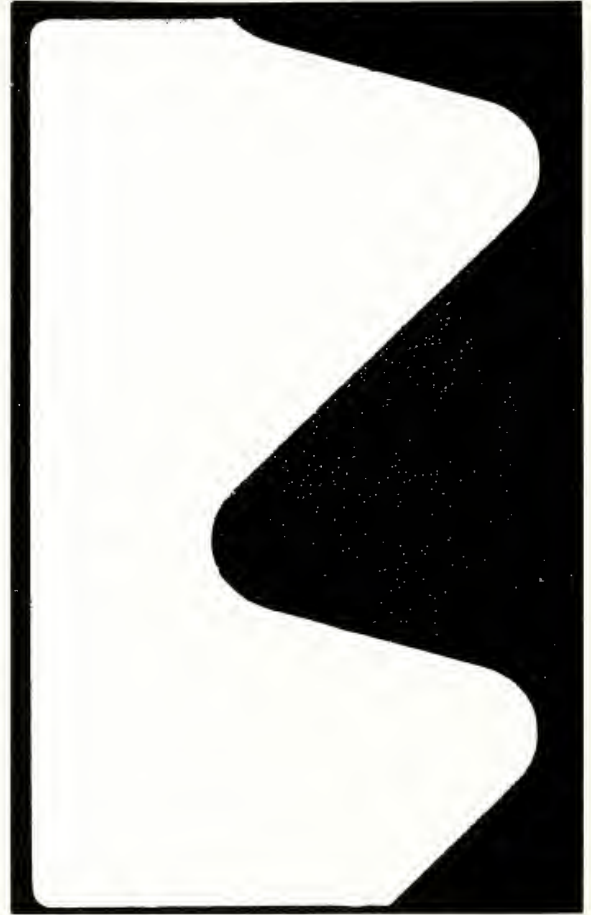
Figure 11b. Thread profile of hub socket No. 1 showing undamaged threads. X 18

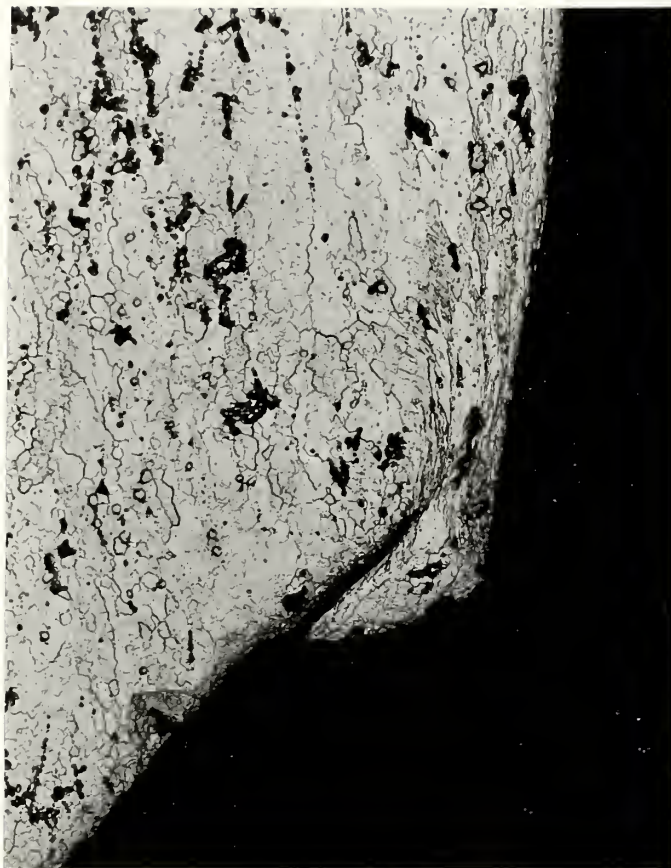
Figure 12. Thread adjacent to fracture in hub socket No. 2 showing deformation. Keller's etch. X 200
